Inspection Report

Mike & Karen Buyers
135 High Bluff
Littletown, NC

Atlantic Inspection Service
Residential & Commercial Inspection Services
Atlnsvc@gmail.com
(252) 903-3977 | Eddie Thornell | License# 2214
3661 SUNSET AVE #207 ROCKY MOUNT, NC

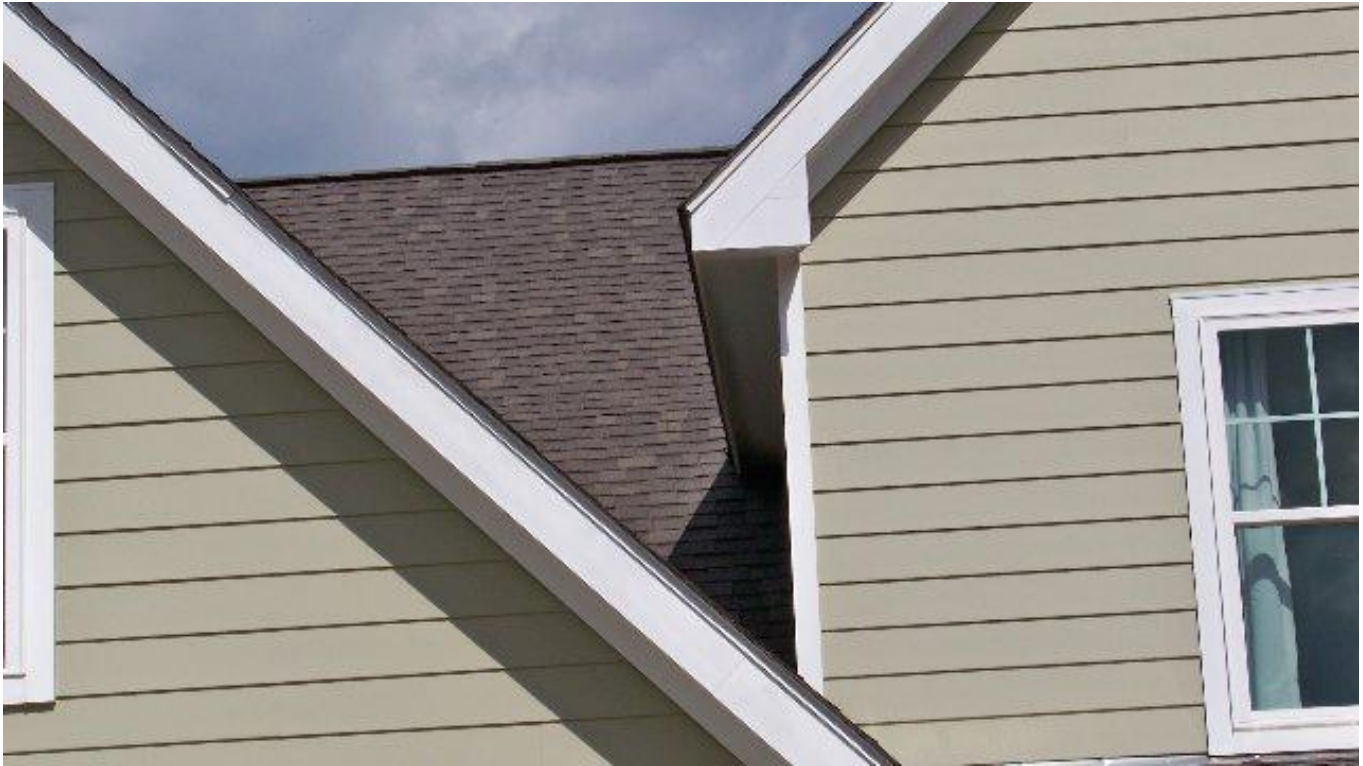
R2

**Roof
dormer configuration at front**

Recommend full gutters installed on front dormers to avoid concentrated run off on lower roof and dormer walls. This will avoid moisture damage to dormer walls and extend life of roof.

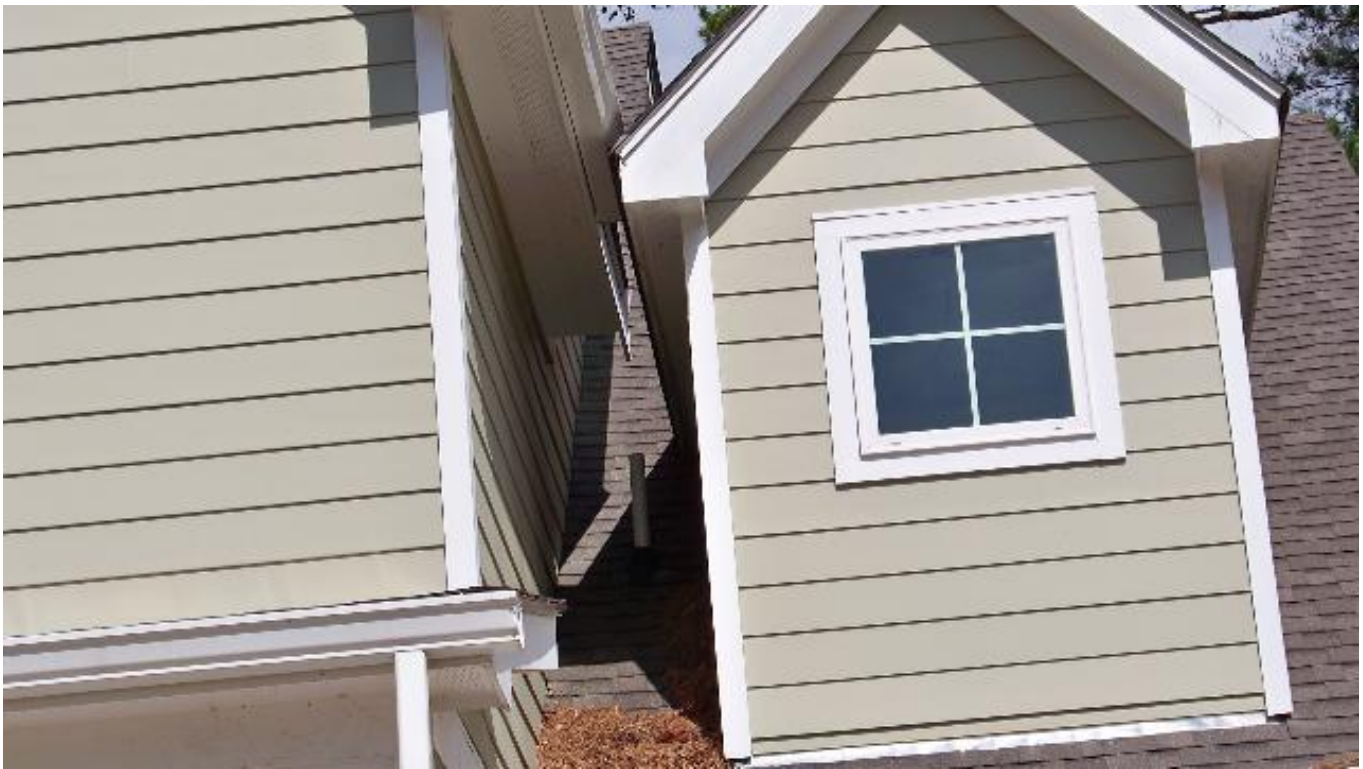
R3

**Roof
dormer configuration at front**

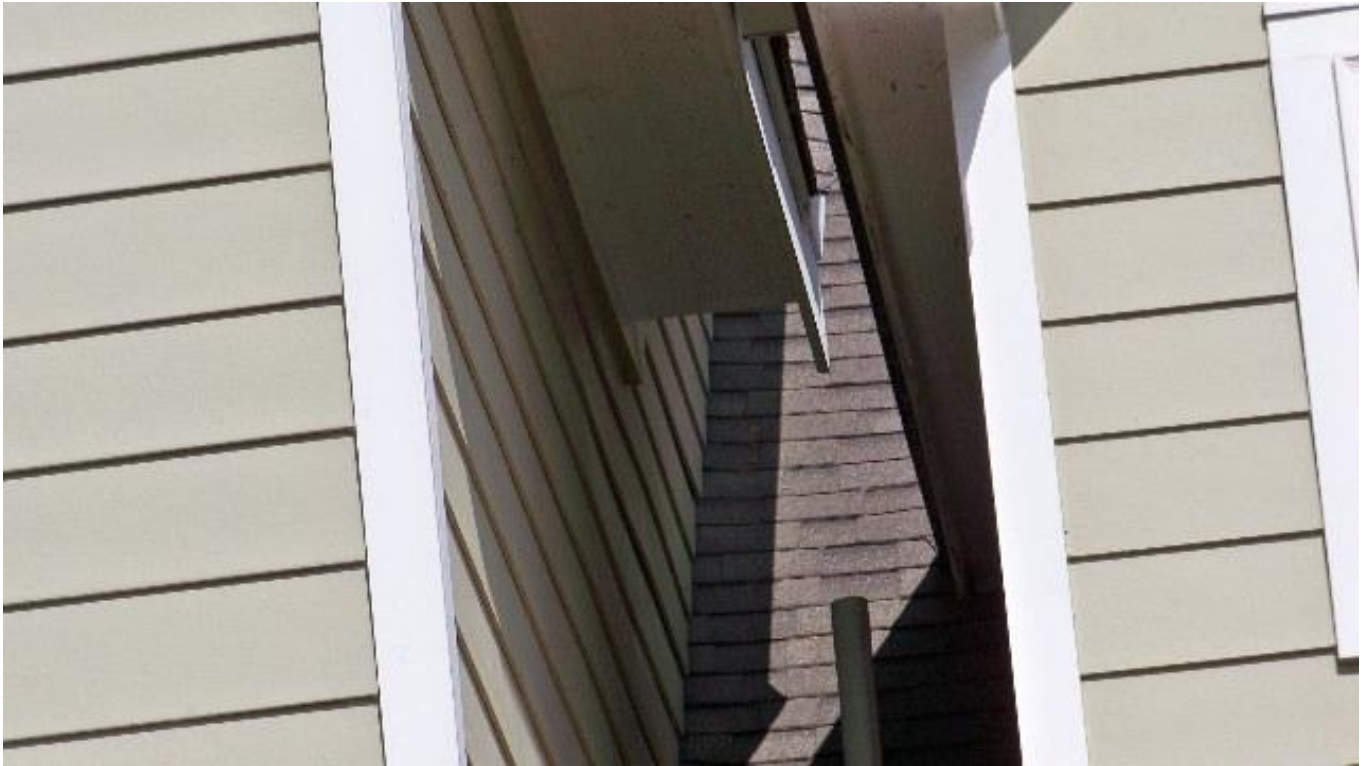
R4

**Roof
dormer configuration at front**

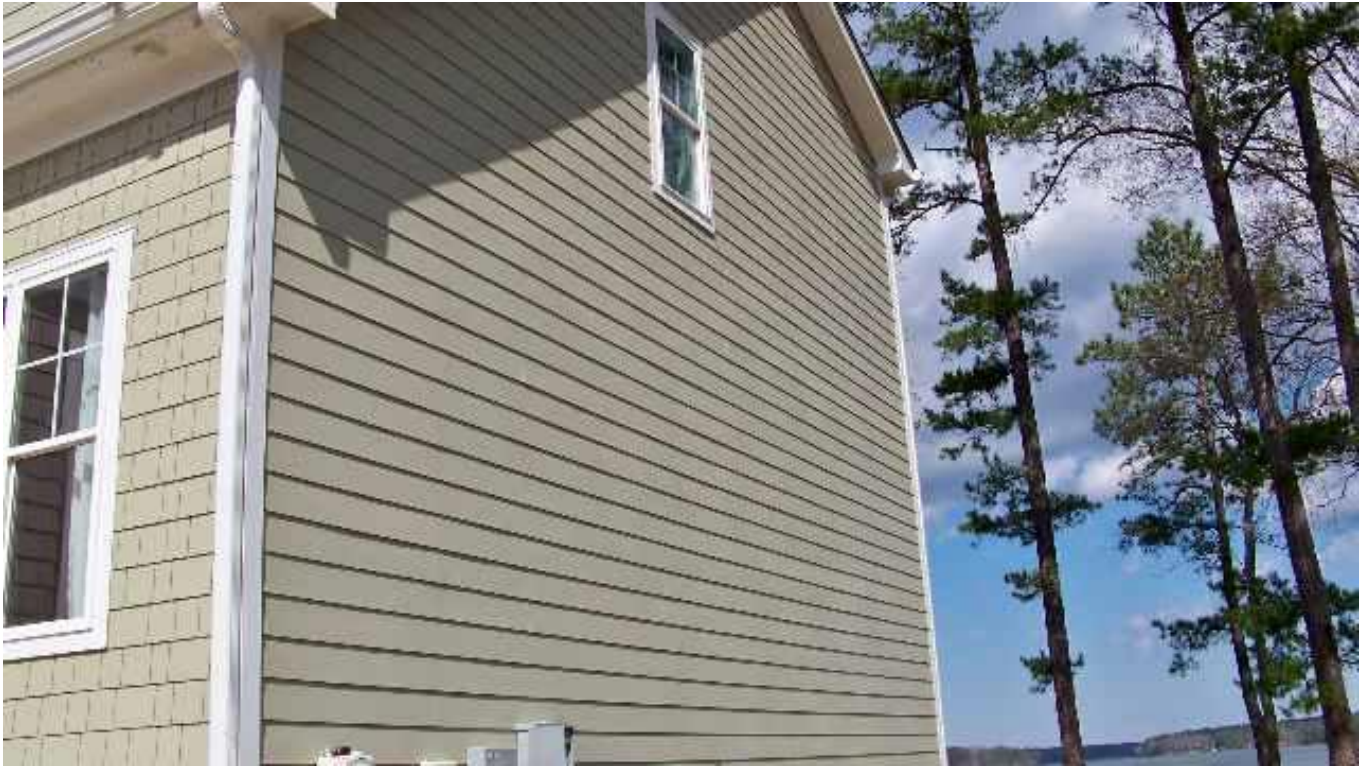
EX5

**Exterior
side**

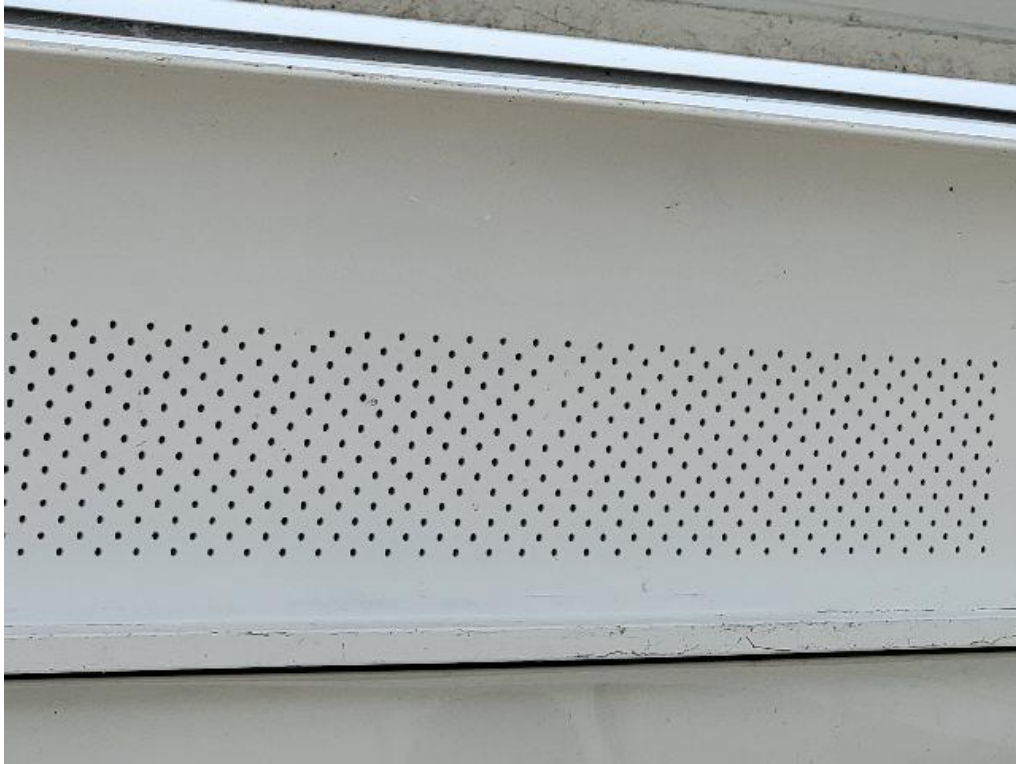
EX12

This attic has been insulated at the roof framing level instead of at the ceiling, this is typical of a closed attic system. however, soffit vents were noted.

**Exterior
ventilated soffit**

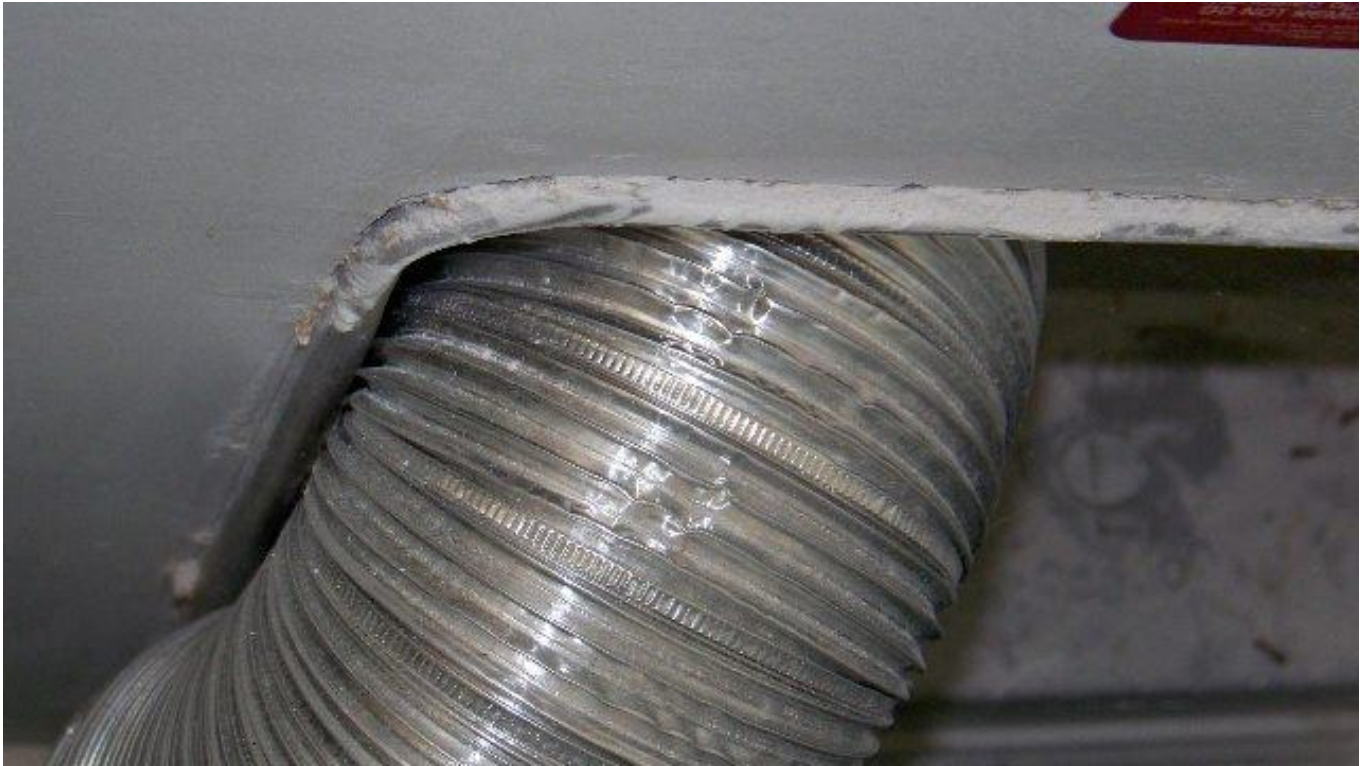
K8

Dryer ducting is flex ducting. Laundry dryers should vent through solid metal ducting to the exterior. Plastic / flex ducting is not rated for this use and it is a safety hazard due to the risk of

**Kitchen & Laundry
flex dryer duct**

Dryer ducting is flex ducting. Laundry dryers should vent through solid metal ducting to the exterior. Plastic / flex ducting is not rated for this use, and it is a safety hazard due to the risk of lint fires and exhaust leakage. Install solid metal ducting.

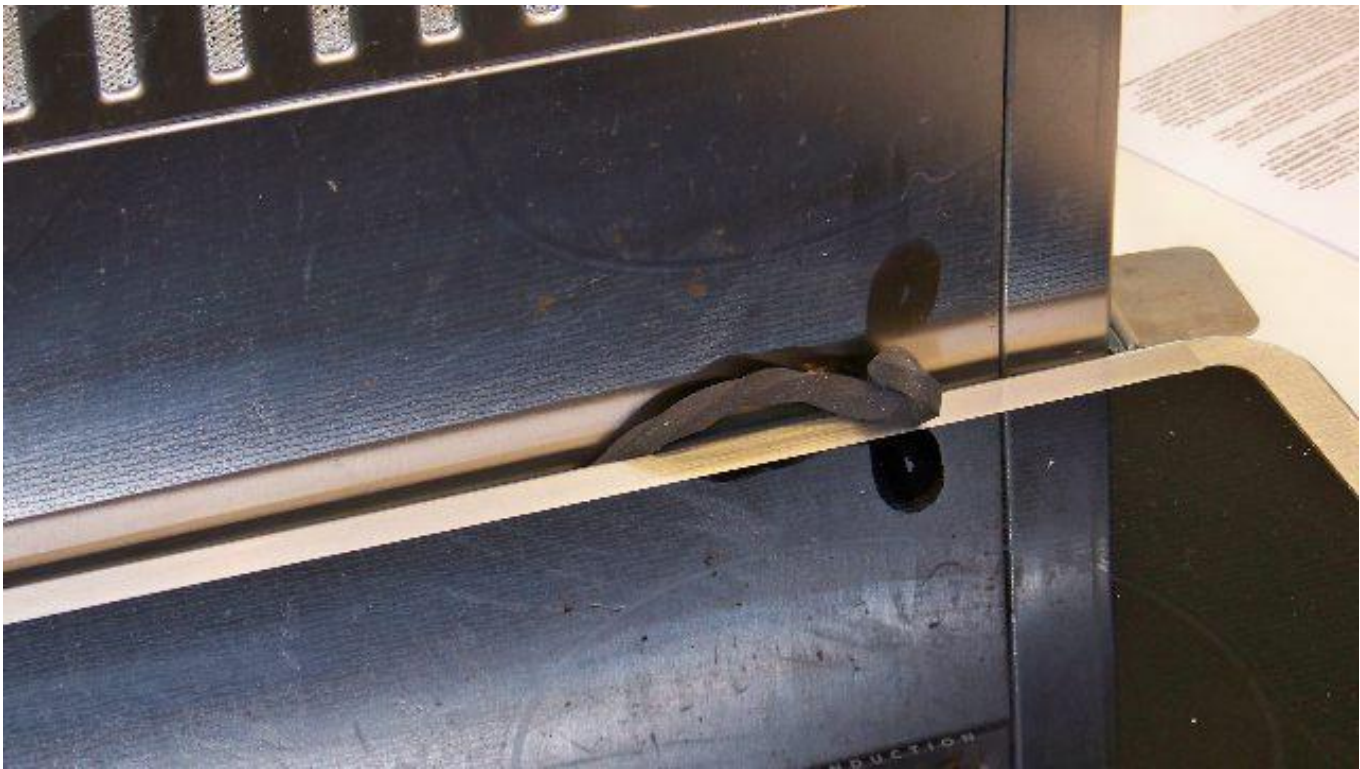
K9

Vent hood gasket is loose. Vent rise and retract operation was slow. Contact an appliance technician to evaluate and repair if required.

**Kitchen & Laundry
loose gasket on range top vent**

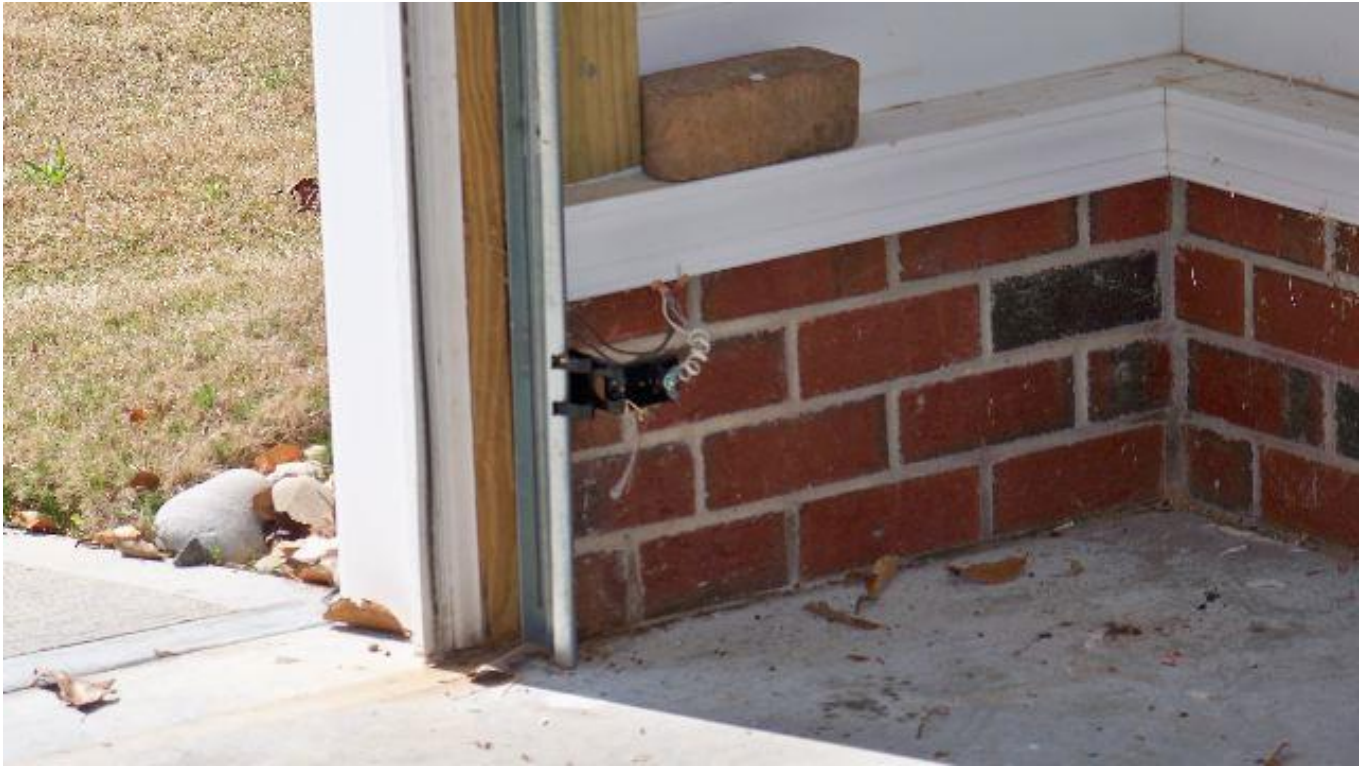
GC7

**Garage & Carport
infrared too high**

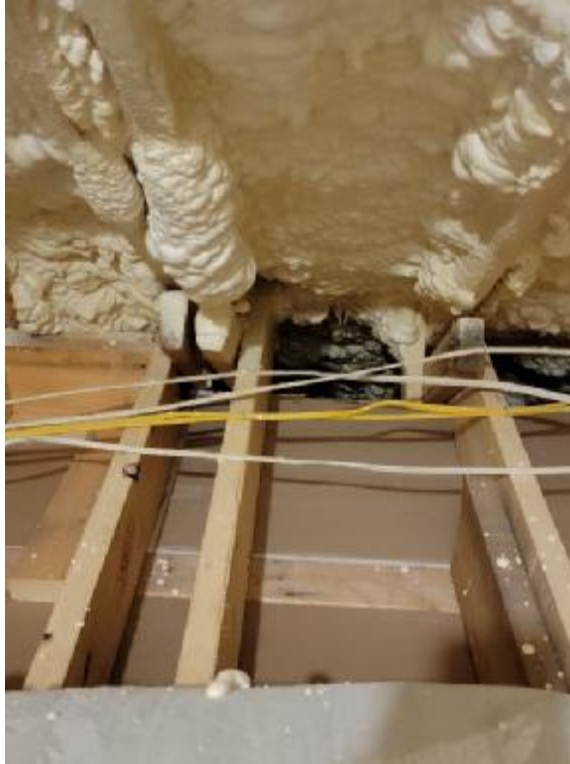
AT10

This configuration could allow outside air to come in contact with conditioned surfaces resulting in condensation.

**Attic
insulation on sheathing none on ceiling**

A lic. general contractor should be consulted for a complete evaluation of building envelope and ventilation / insulation configuration and perform repairs as needed.

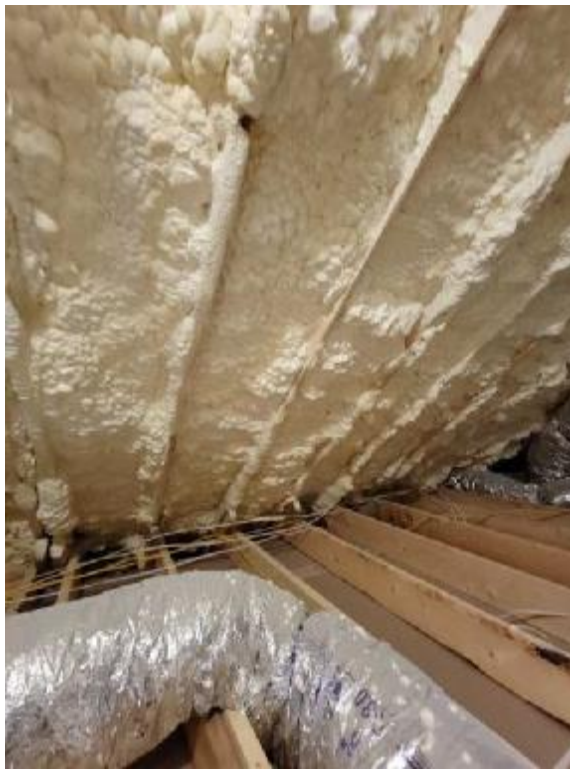
AT11

**Attic
spray foam insulation**
